Performance Assessment of GFRP Rebars Used in an Existing Bridge

Ali F. Al-Khafaji (Graduate Research Assistant), Prof. John J. Myers (Advisor)

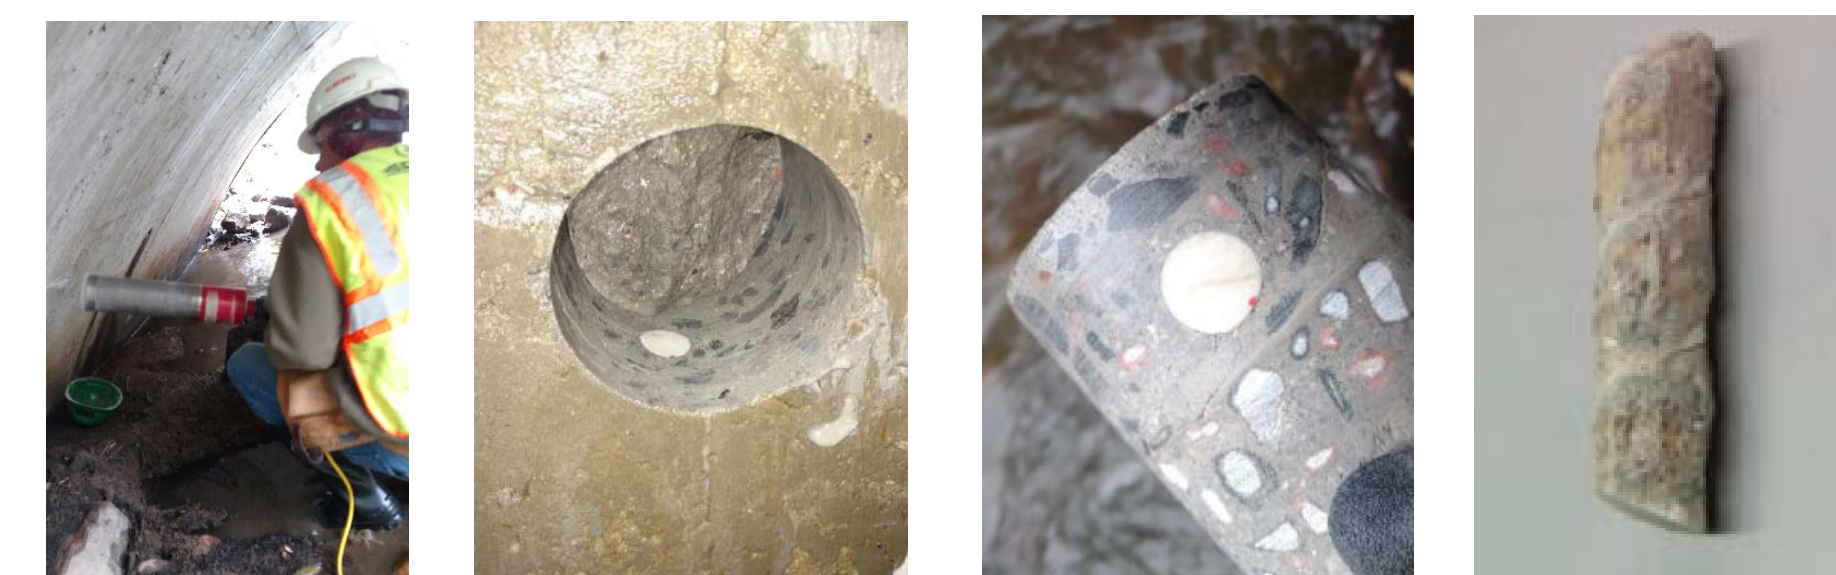
GFRP Rebars Extraction

Extraction of the concrete core from the Bridge, then Extraction of the GFRP rebars pieces from the concrete core

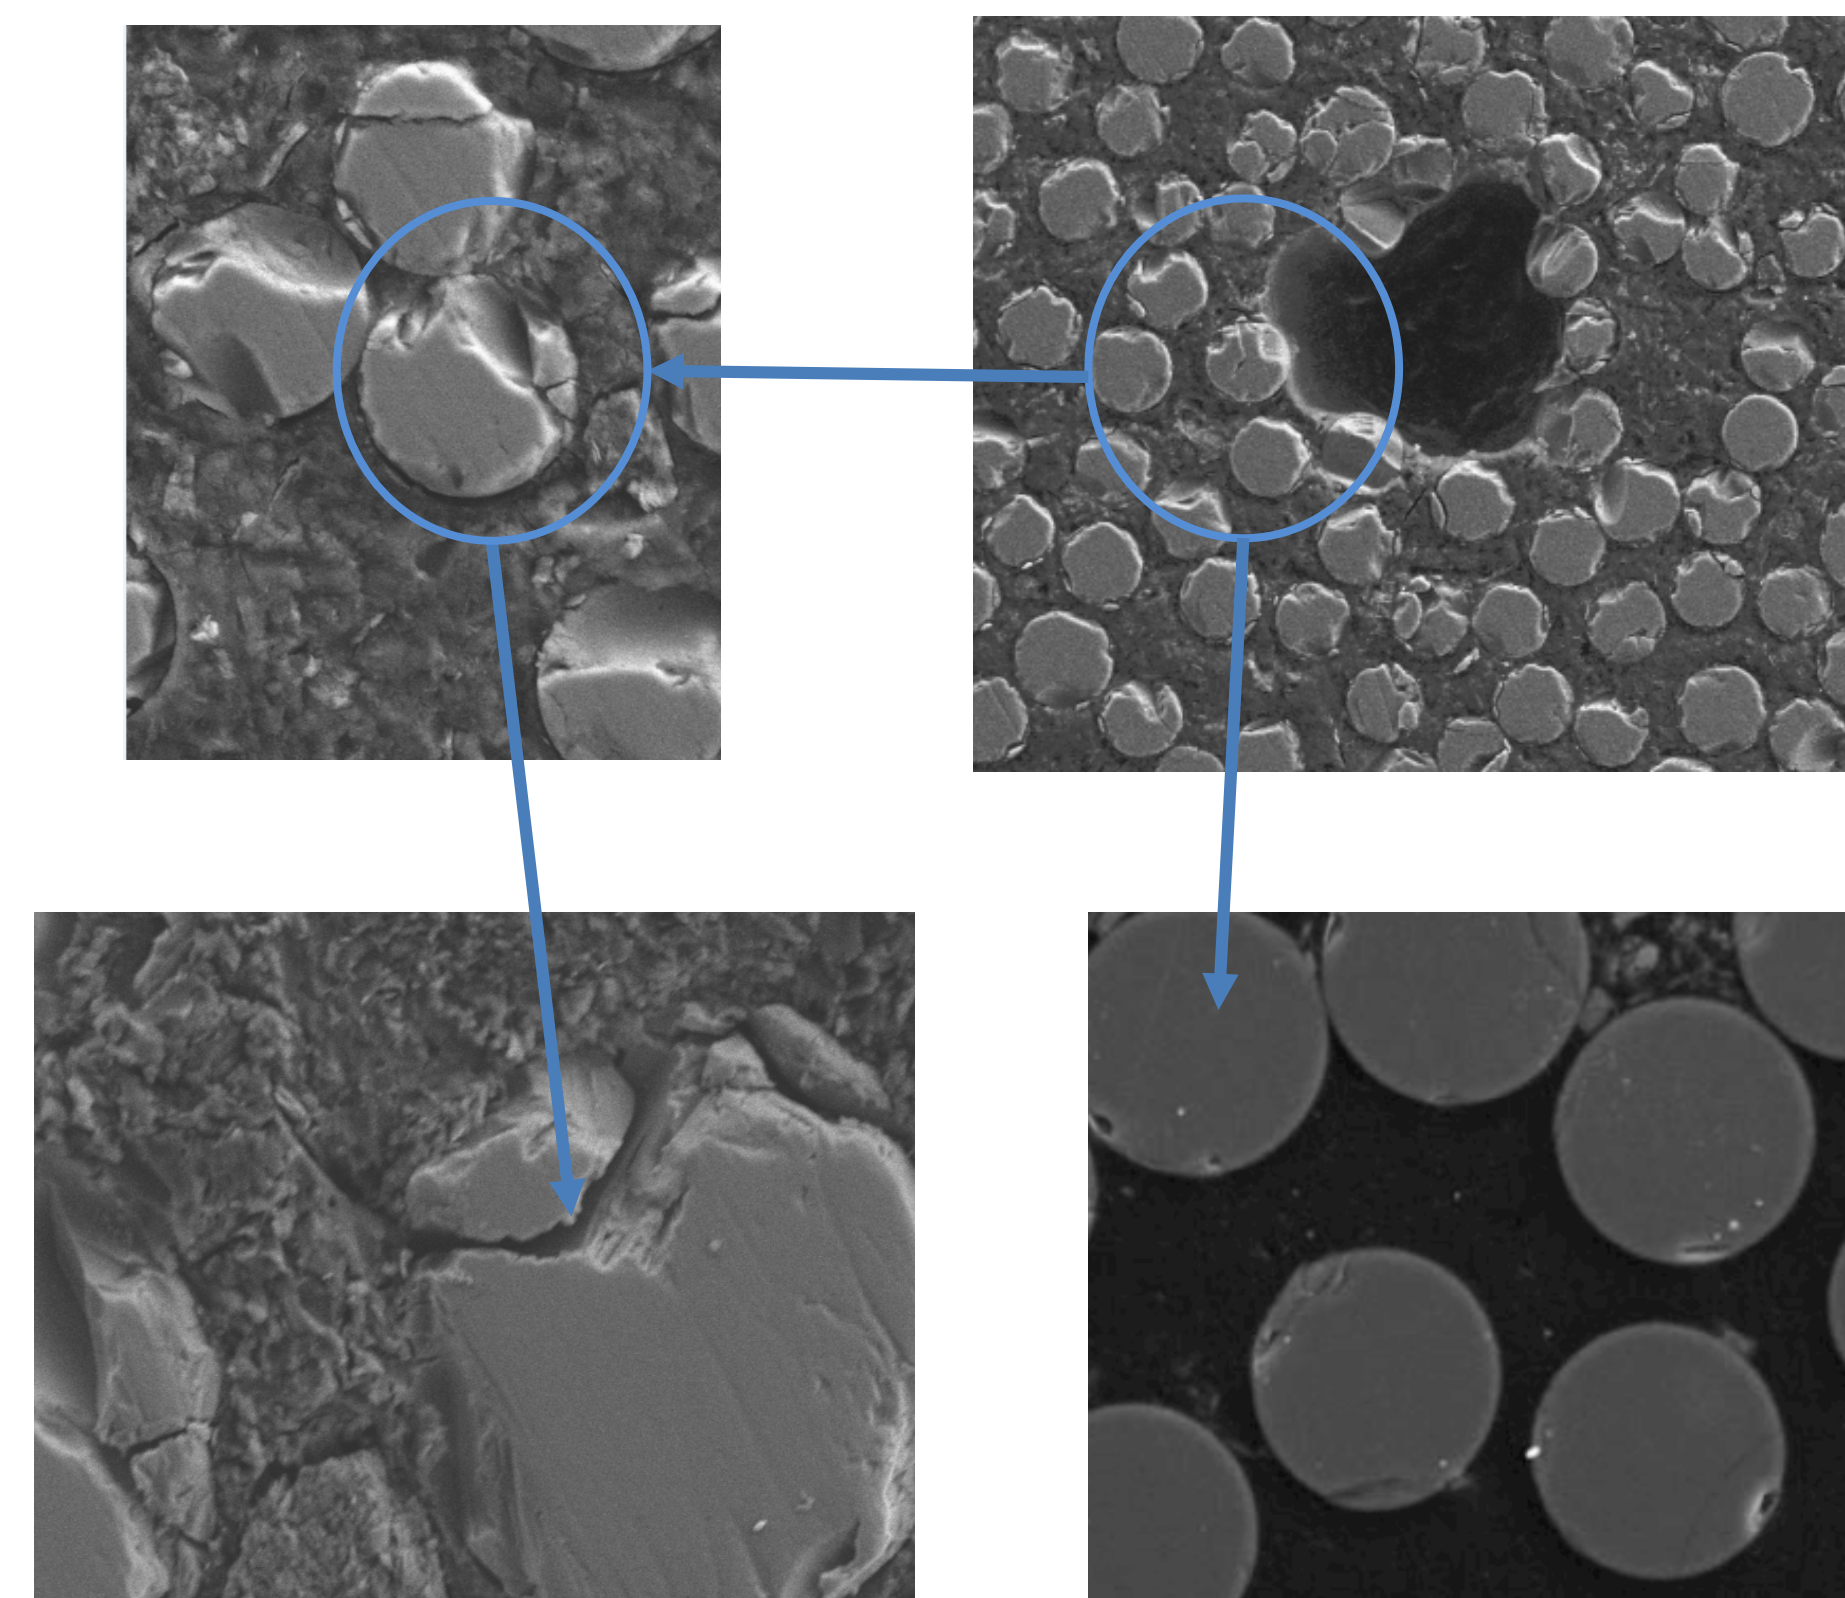
Scanning Electron Microscopy (SEM)

- SEM analysis showed some microstructural degradation.
- There was no loss in any cross-sectional area of the bar.
- SBS test results were a little higher than the results of Owens, need more specimen for justification.
- Tg results showed a significant reduction in temp (about 20 C less)
- Burn-Off test results showed that fiber content in the tested samples were close to the ones tested at UM
